Meeting of St Ouen's Roads Committee

11 April 2025 at 14:00

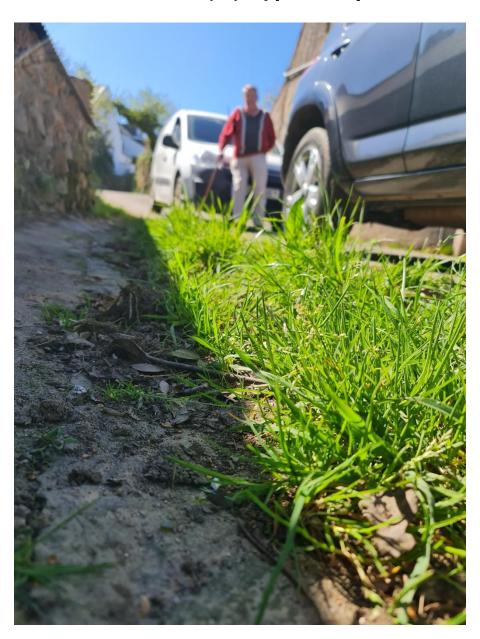
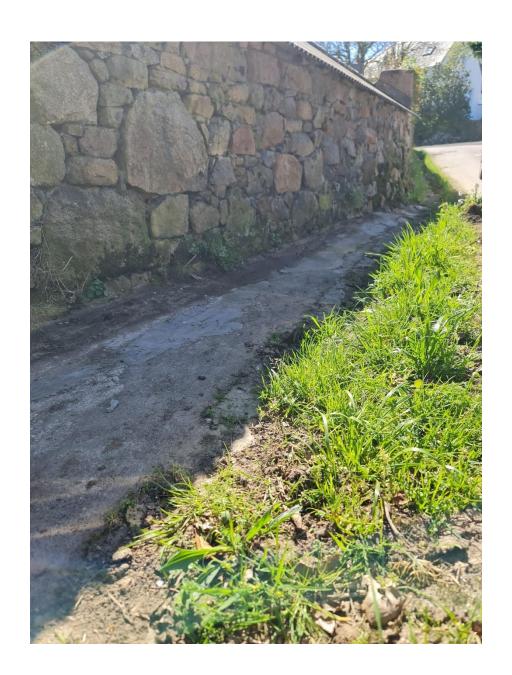
Relief of the property [REDACTED]

2. The Roads Committee attended the property known as [REDACTED]. The Committee noted that a concrete outbuilding used as a shed sits on the roadside.

MLM said the gulley running alongside the road was situated on the property relief. JA added that the base of the shed sat some 4-5 inches higher than the gulley and if the relief was cleared of growth, it would significantly reduce the volume of water that ran down. He said that this should be the first action, then the relief could be cemented over to stop the water ingress. Images of the relief and gulley are included in Appendix A.

The Committee agreed this should be the first action and noted the relief was the owner's responsibility to maintain.
